HITLER'S TANKS

GERMAN PANZERS OF WORLD WAR II

EDITED BY
CHRIS McNAB

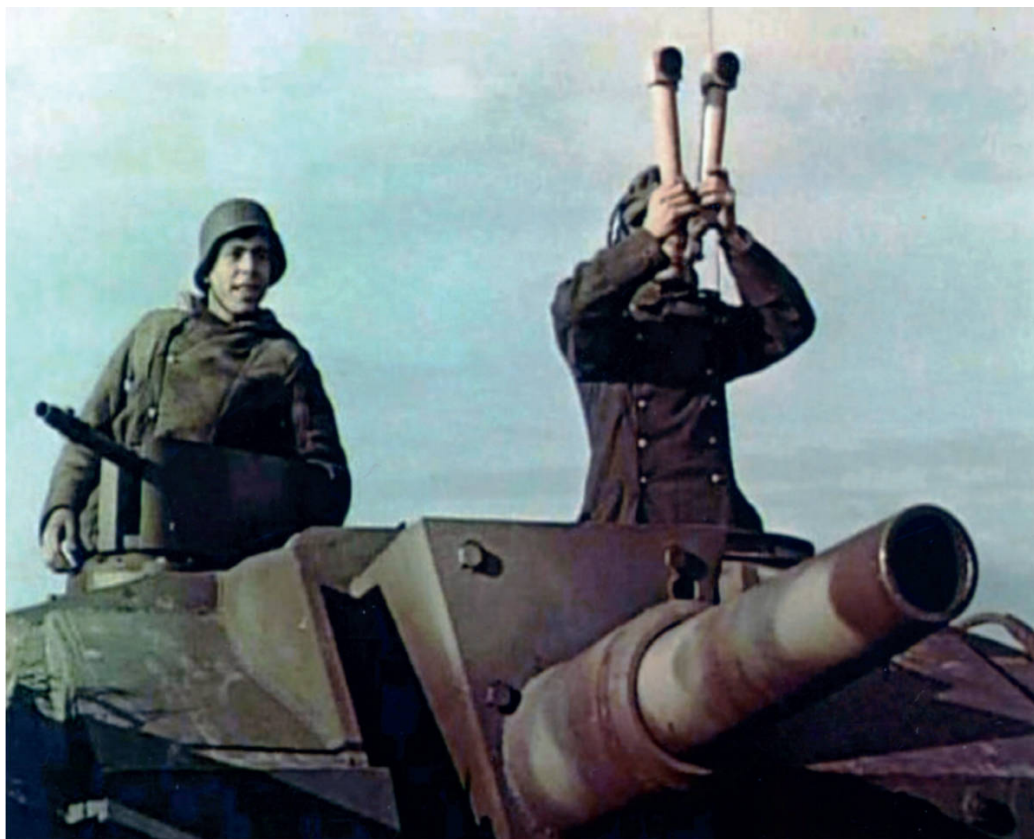
This German tank commander, the leader on a Sturmhaubitze 42, is using S.F.14 Scherenfernrohr Gi H/6400 periscope-type artillery ranging optics to spot potential targets.
(AirSeaLand/Cody)
